# Troll C Subsea

Complex Subsea Repair of Manifold N1

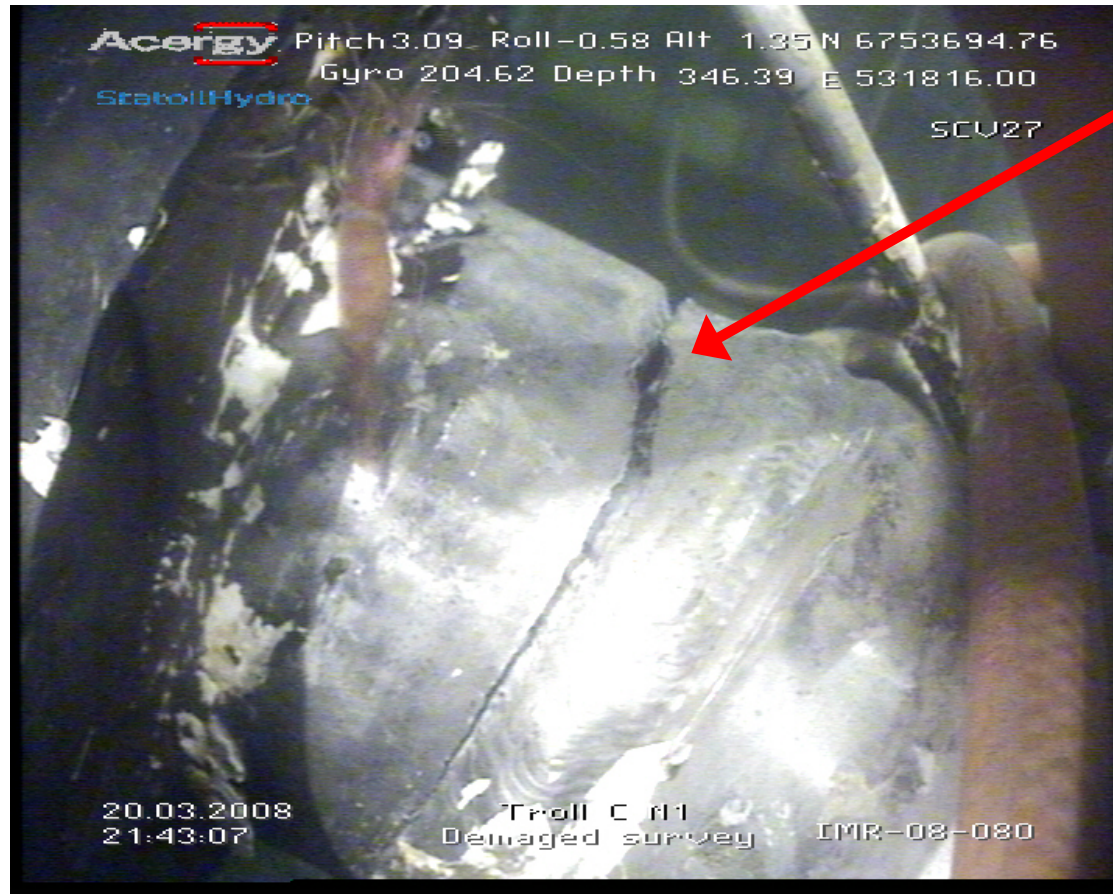
# Crack in 6" Production Pipe

- Crack in pipe allowing pipeline content leaking to sea.
- One valve as barrier between open sea and 10" Test Header pipeline.
- Barriers not in accordance with requirements, Test Header pipeline shut down.
