DIVERLESS BRACE INSTALLATION - VARG A

Varg A – Monotower wellhead platform Water depth approx. 84 meters

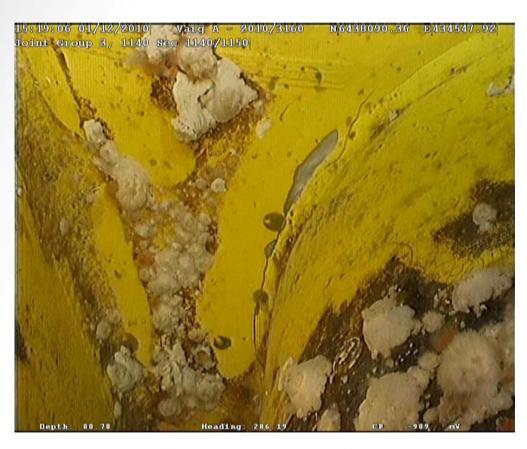
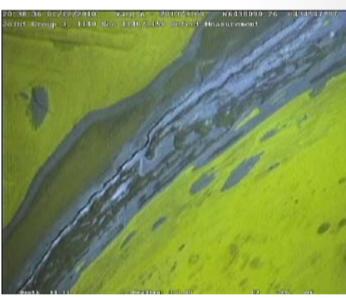
Crack in brace discovered by DeepOcean during the yearly inspection campaign

Brace outer diameter – Approx. 1 m

Crack located in weld seam from 7 to 11 o'clock in complex location for ROV and ROV tooling access

Campaign 1 – Drilling of 3 holes to prevent further crack development

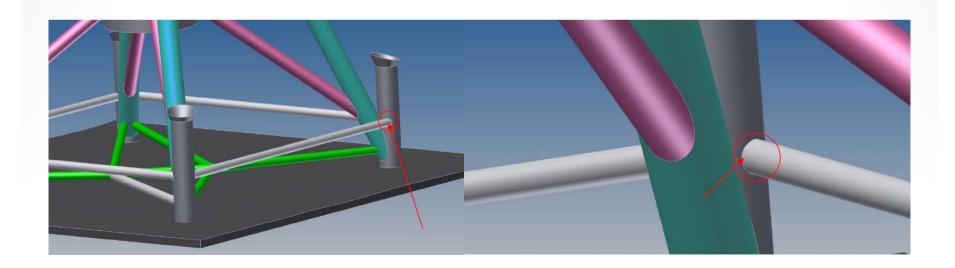
Study: Closed and Hinged Clamp Evaluated

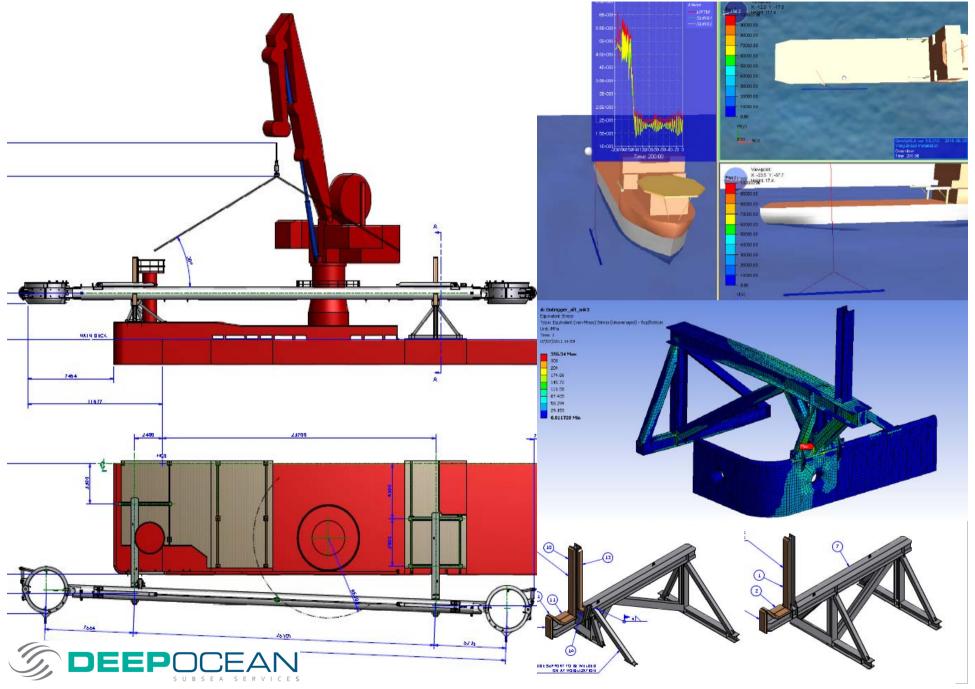
Campaign 2 - Preparations : Design of outriggers and SIMO analyses

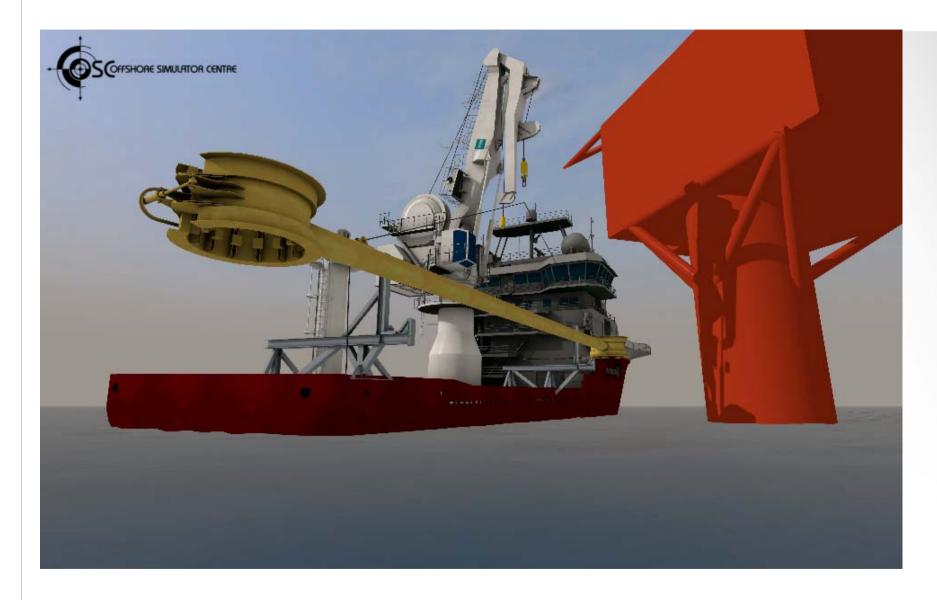
Campaign 2 Preparations Simulator training offshore lifts

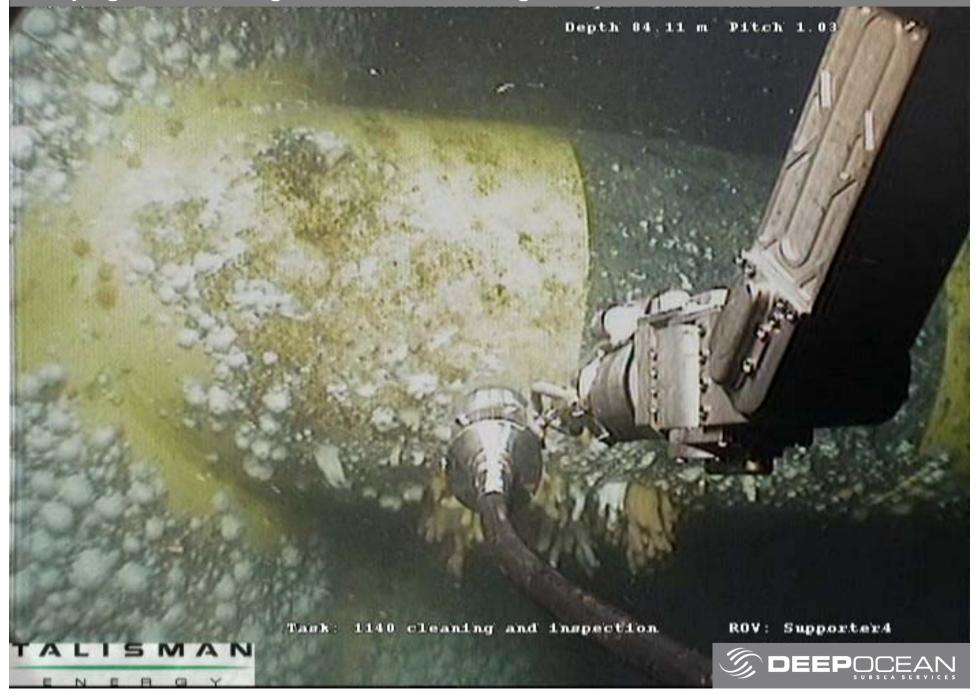
Campaign 1 – Cleaning / removal of marine growth

Campaign 1 – Removal of 12 anodes and other obstructions Depth TALISMAN Task: Anode removal, north west cor

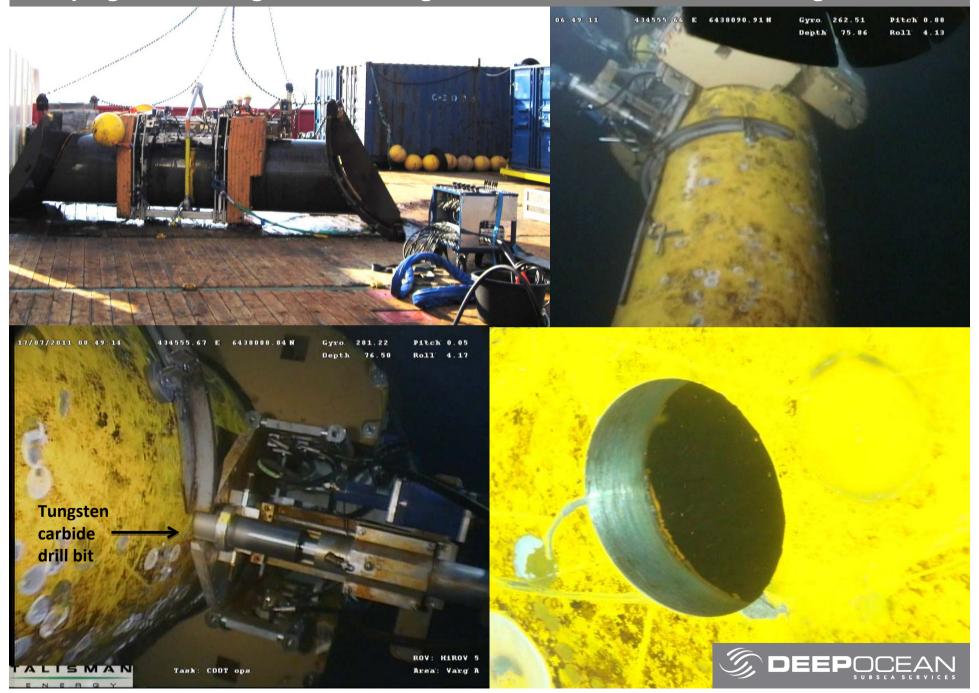
Campaign 1 – Drilling of 4 off 90 degree holes to accomodate for lifting aids

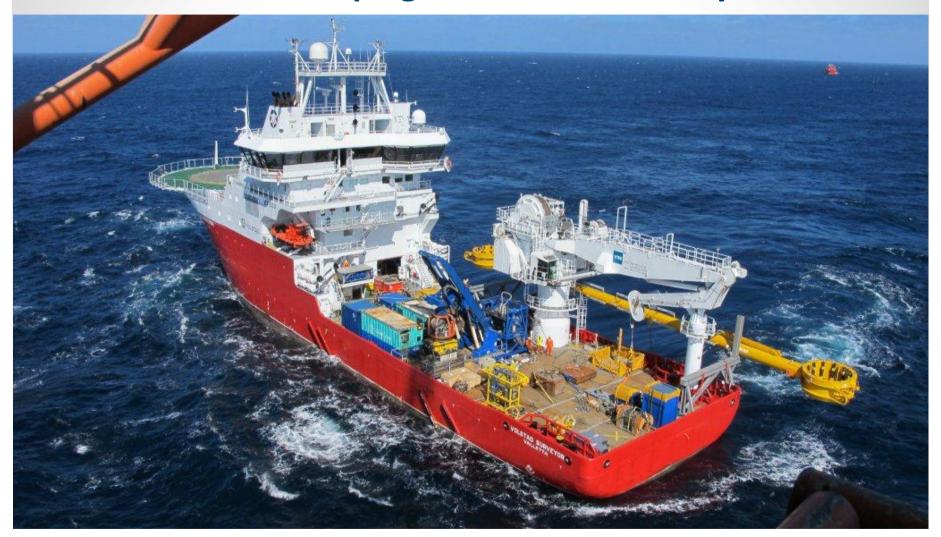
Lower through splash zone with holdback tugger lines to control brace

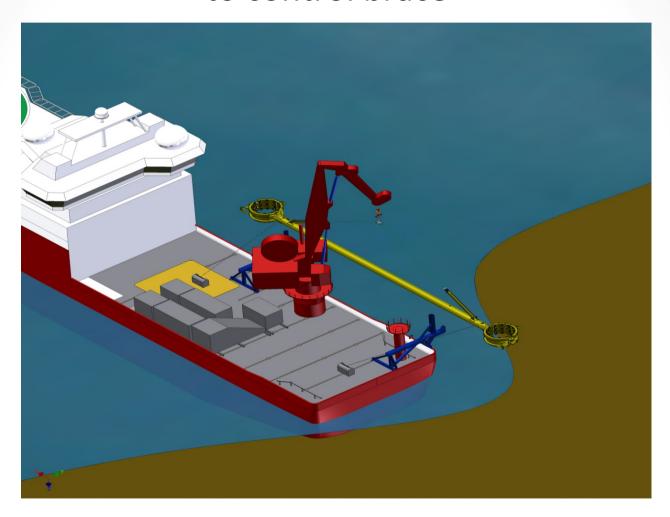
Continue lowering & monitoring with ROV's

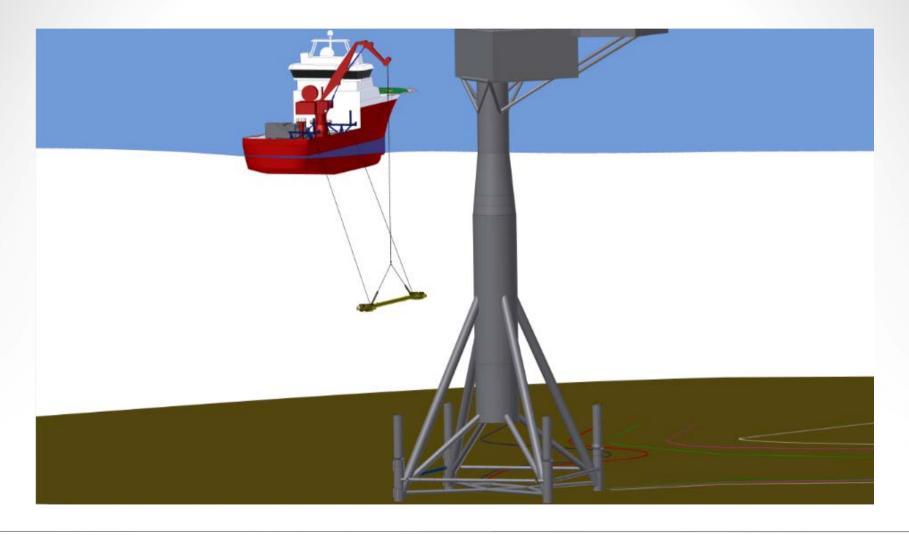
Disconnect tugger winch lines Reconnect as guide wires via DMA's

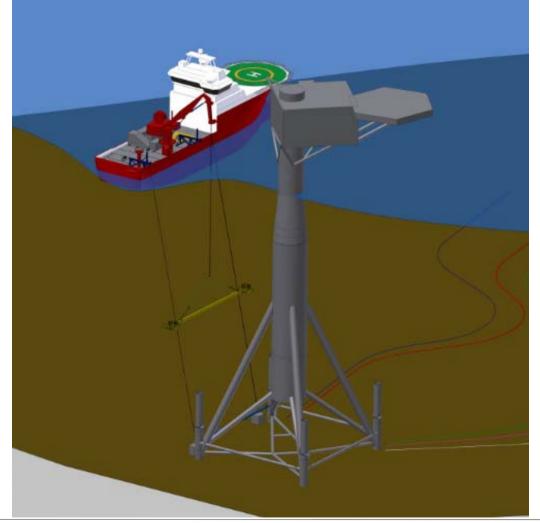
Change from holdback wire to guide wire mode

(ROV disconnects wire, passes through masterlink & connects to DMA on seabed)

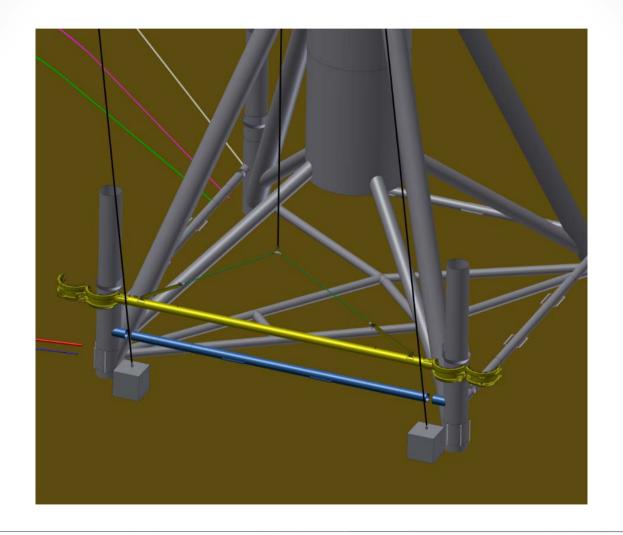
Install hang-off rigging w/ ROV operated hydraulic chain blocks

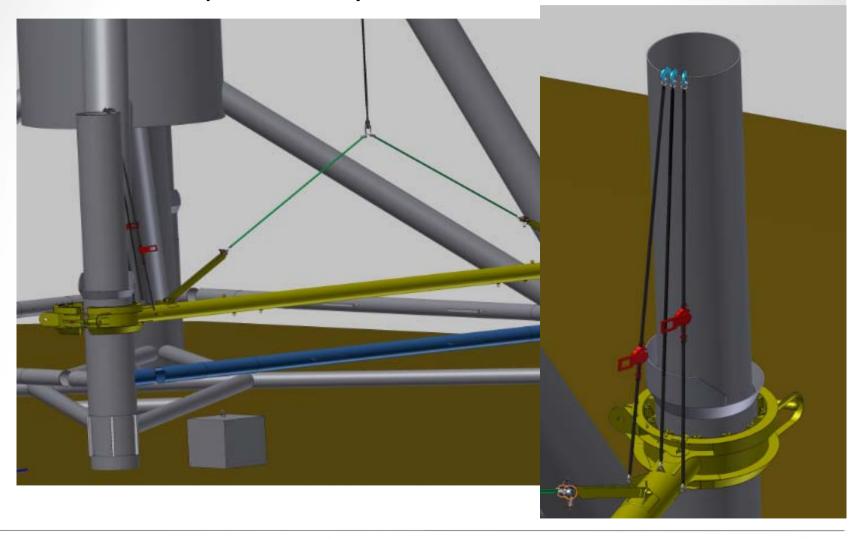
Clamp fully closed in final position 383mm clearance

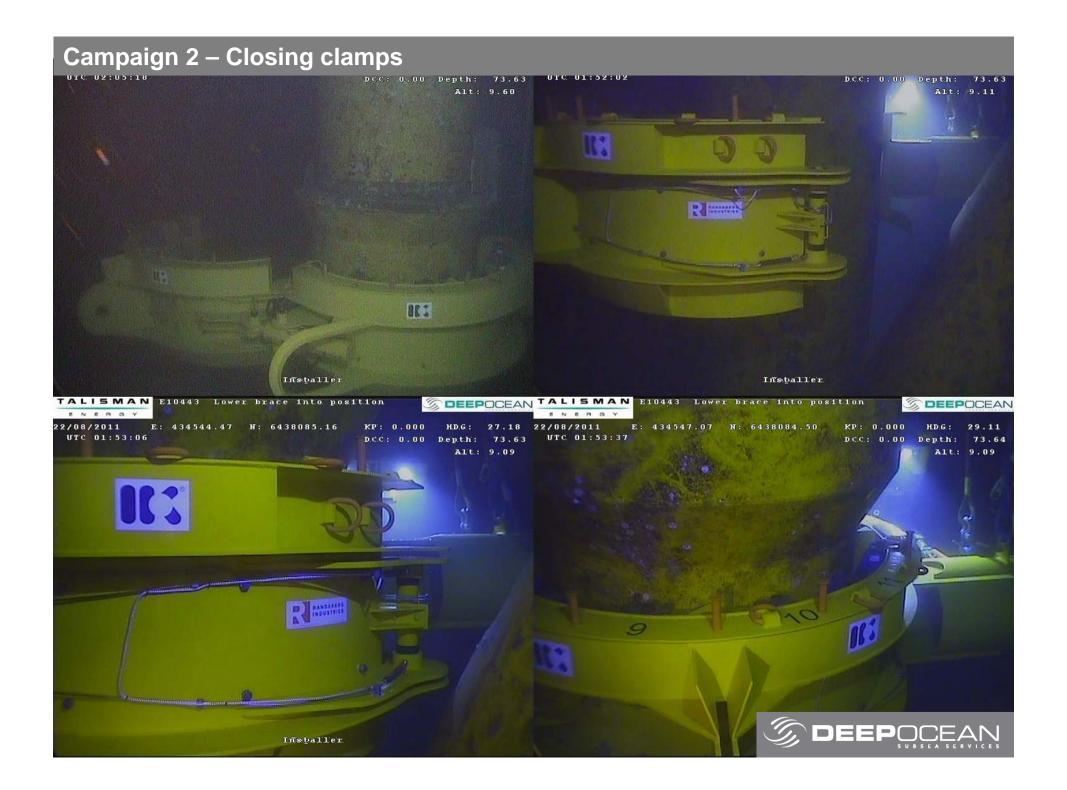
Campaign 2 – Locking clamps, aligning & levelleling D.C.C.: 0.00 Depth: 73.65 Alt: 9.10 E: 434549.27 N: 6438095.05 08/2011 DCC: 0.00 Depth: 55.28 TC 15:31:43 Alit:: 29.93 Instablier. © DEEPOCEAN TALISMAN E10443 Final contl mesurm of Brace TALISMAN E10443 Final contl mesurm of Brace TO DEEPOCEAN ENERGY 22/08/2011 KP: 0.000 E: 434585.12 N: 6438093.23 E: 434579.49 N: 6438091.50 HDG: 181.21 22/08/2011 KP: 0.000 HDG: 188.25 UTC 08:24:46 UTC 10:02:39 DCC: 0.00 Depth: 73.21 D.C.C.: 0.00 Depth: 73.05 Alt: 10.12 Suppossite Supporter

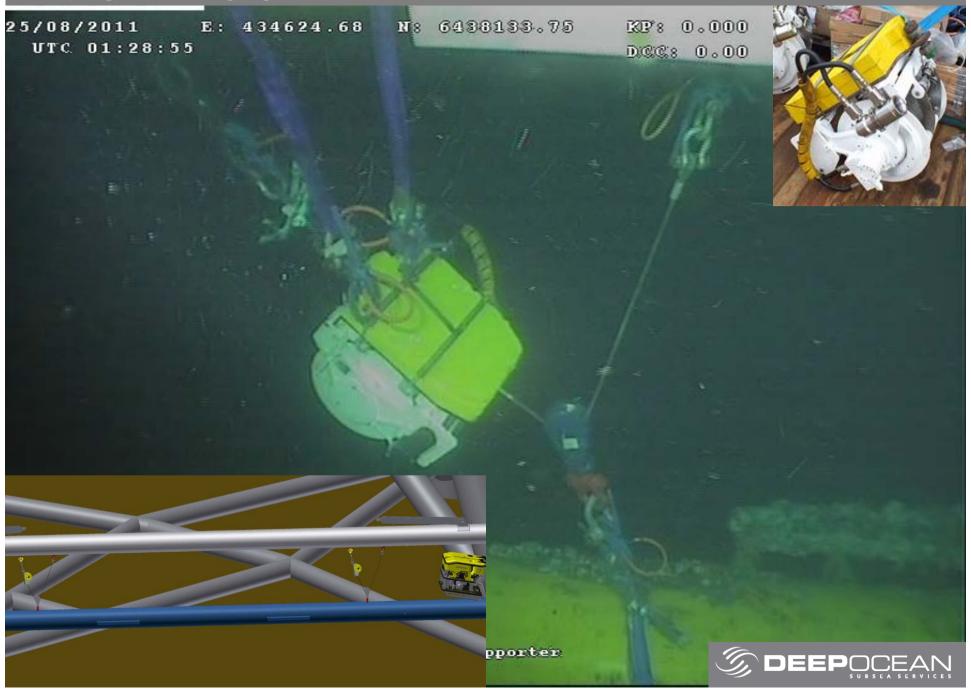
Campaign 2 – Cutting old brace
