# Troll C Subsea

Complex Subsea Repair of Manifold N1

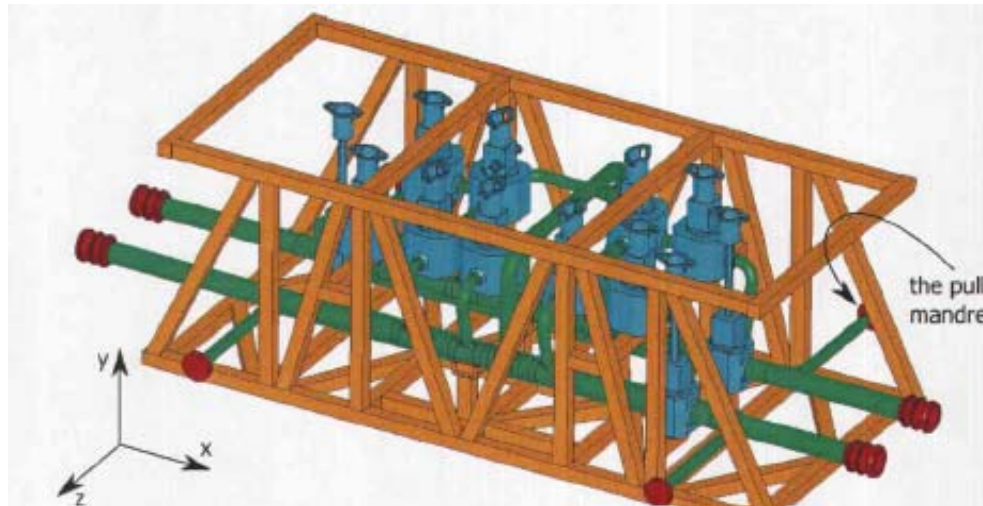
- New Manifold

- Budget DG2            1530 MNOK
  - Ex. production loss
- Project Schedule 28 Months
- Overall low risk level
  - Disconnection of all flowlines and umbilicals
  - Long shut down period for Manifold N1 and N2 (7 wells for min. 4 months)

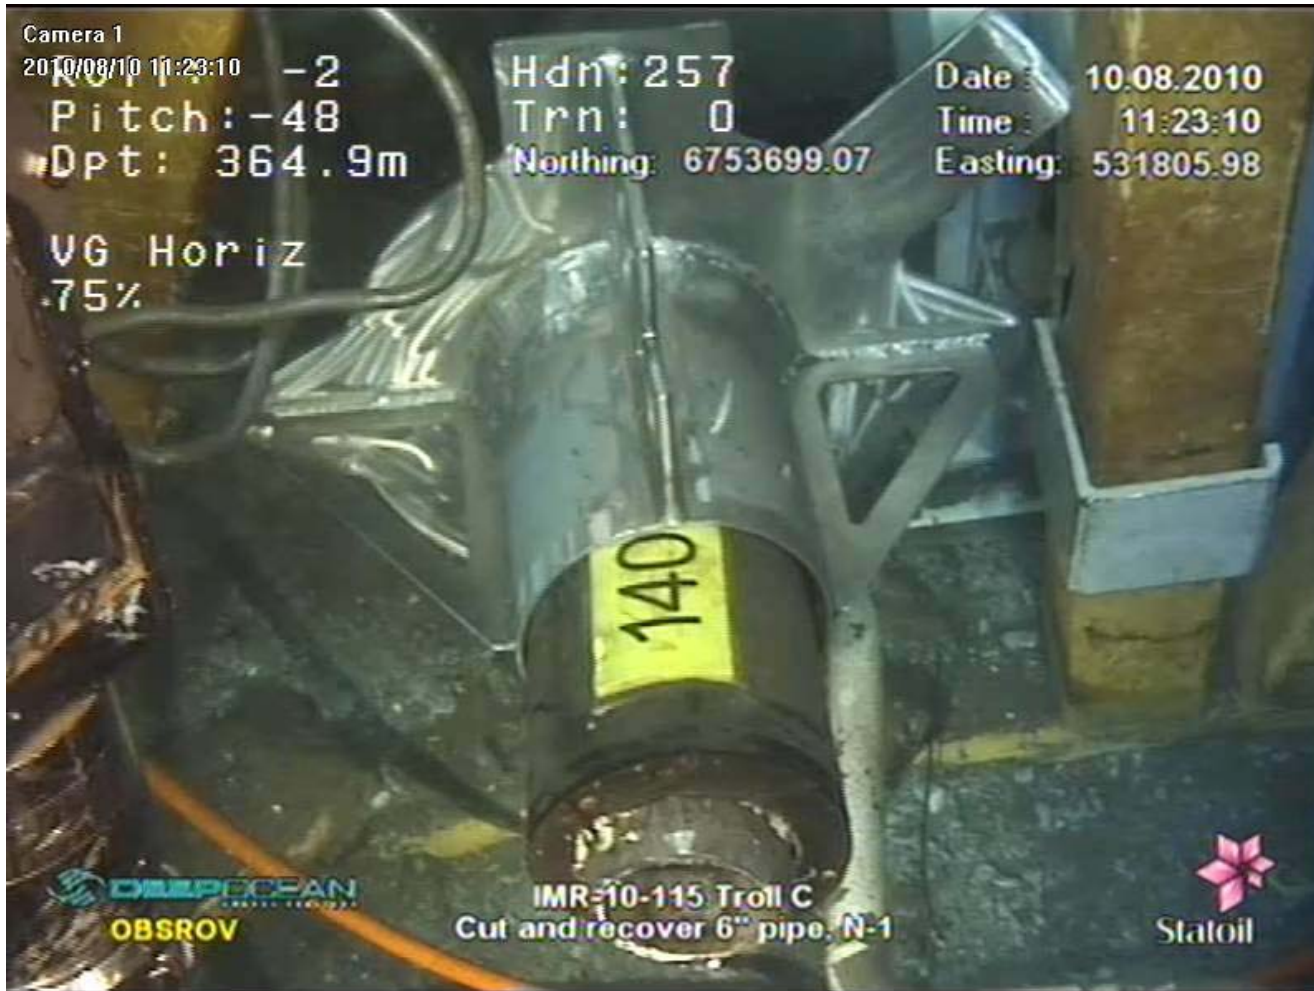
# Use of Dummy Models

- Access for Repair
- Performed photogrammetry survey and created a 3D model early in the project. 3D model used for all tools and equipment development.
- Dummy manifold and well base fabricated based on 3D model and extensively used during testing and site integration.
