# Deepwater hydrate detection and characterization with Acoustic Resonance Technology (ART)

FFU-Seminar 2025  
Johannes Dahl  
TSC Subsea

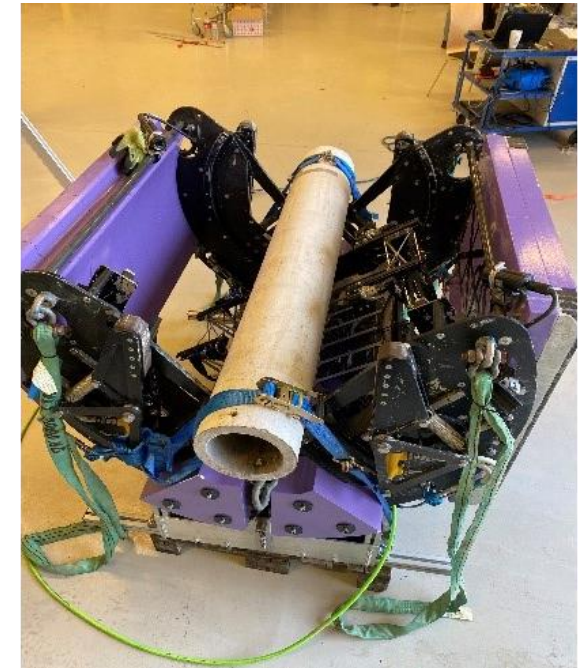
- Lab testing proved that the current configuration offered robust and repeatable results
- However, a new system system needed match the ROV speed and maintain the robustness and repeatability

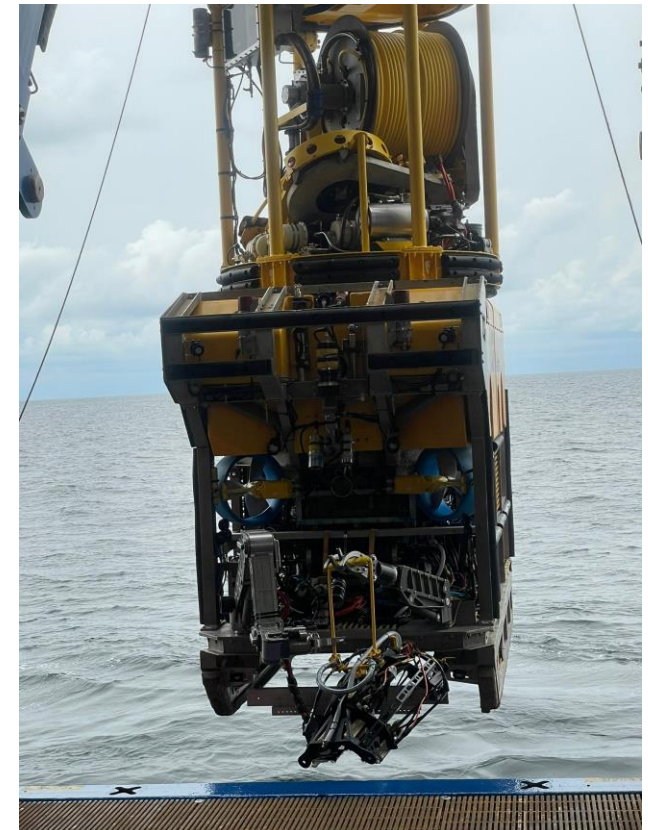
- 12 km continuous scanning in 33 hrs
- Hydrate plug located and sized
- High-speed data collection minimising ROV & Vessel time
- Through-coating inspection, eliminates coating removal/reinstatment
- Minimal dredging requirements

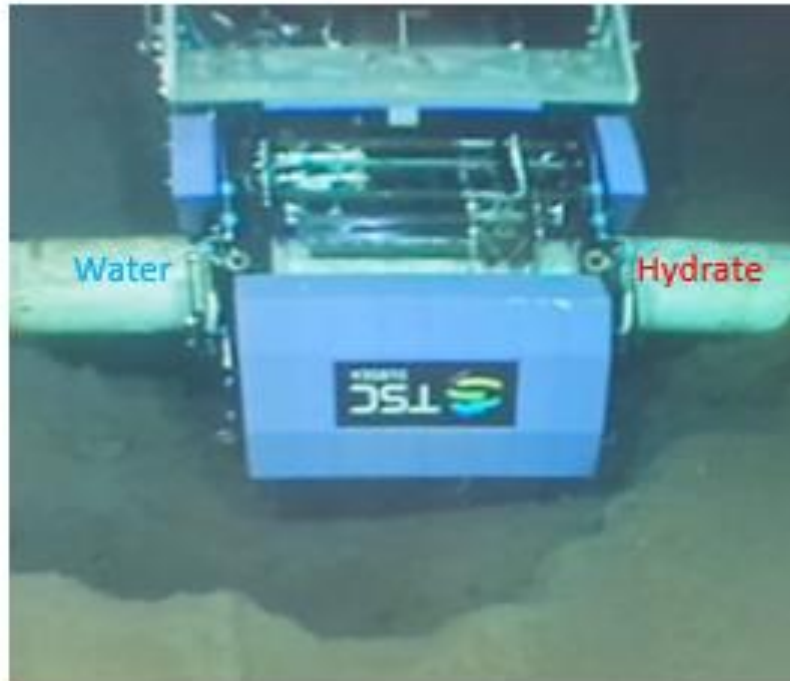
# Offshore Validation Results

360 high resolution Scanning
